CONNECTICUT RIVER BASIN
CANAAN, NEW HAMPSHIRE

GOOSE POND DAM
NH 00118

PHASE I INSPECTION REPORT
NATIONAL DAM INSPECTION PROGRAM

MAY 1979

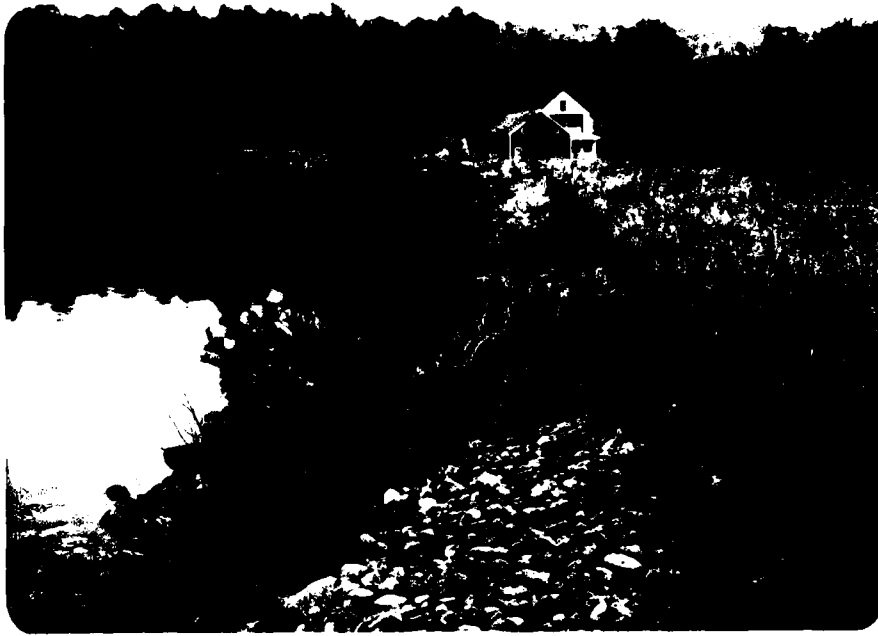
Vegetation, consisting of grass and weeds, was noted on the upstream slopes and on the top of the dam. Small bushes were observed on the downstream slope.

1. Goose Pond Dam, Looking East. Showing Vegetation on the Upstream Side of Core Wall.

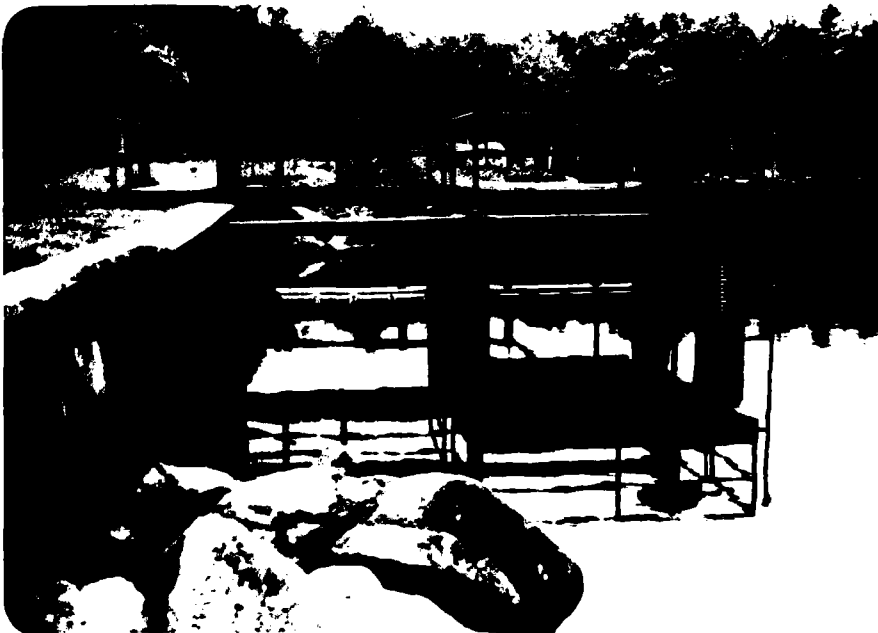
2. Intake Structure with Rectangular Spillway.

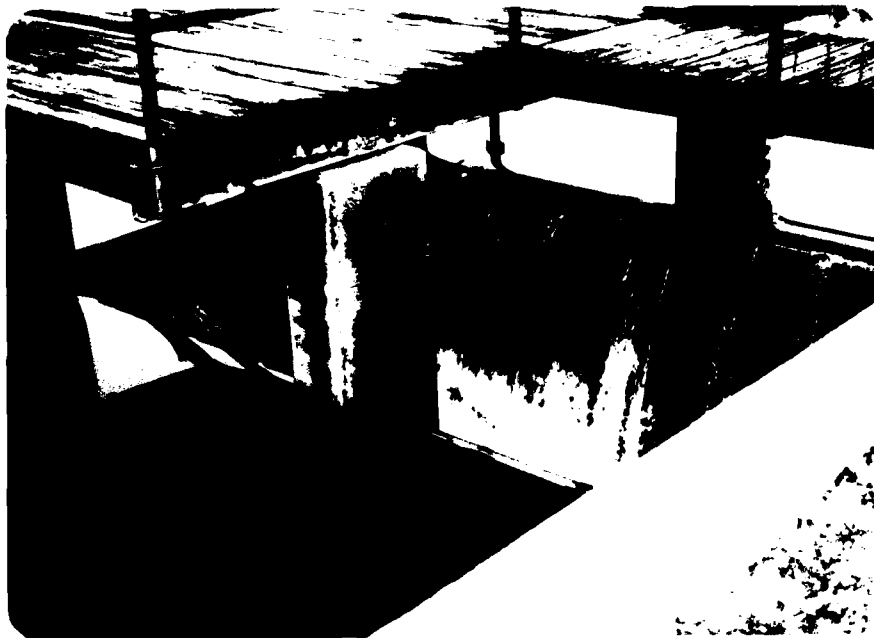
The crest of the non-overflow section is 11 feet above the crest of the spillway. At the time of inspection, water was observed flowing over the flashboards on the spillway crest. The hydraulic design of the spillway is good.

3. Spillway Crest with Flashboards in Place, Looking Northwest.

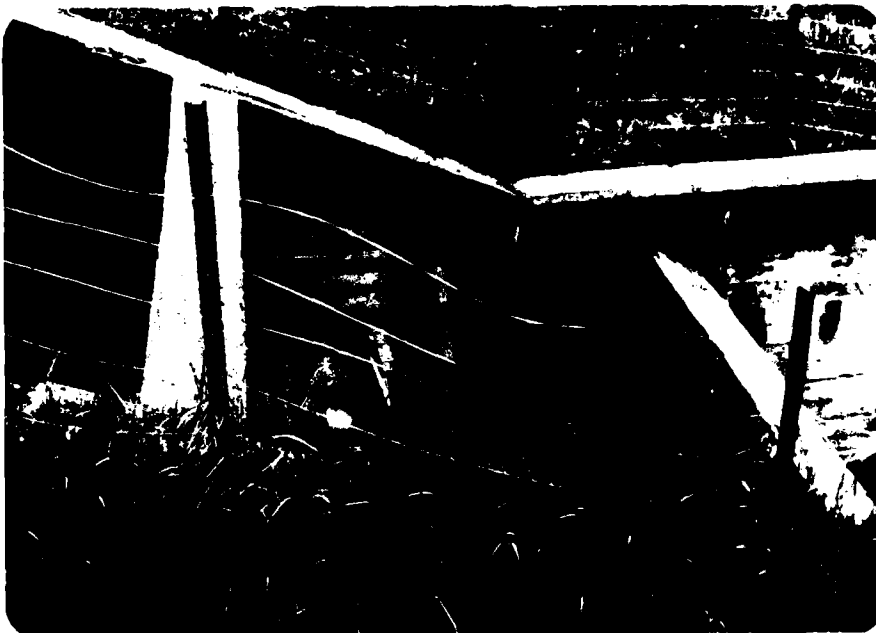
6. Discharge Channel with Cross Beams, Looking East.

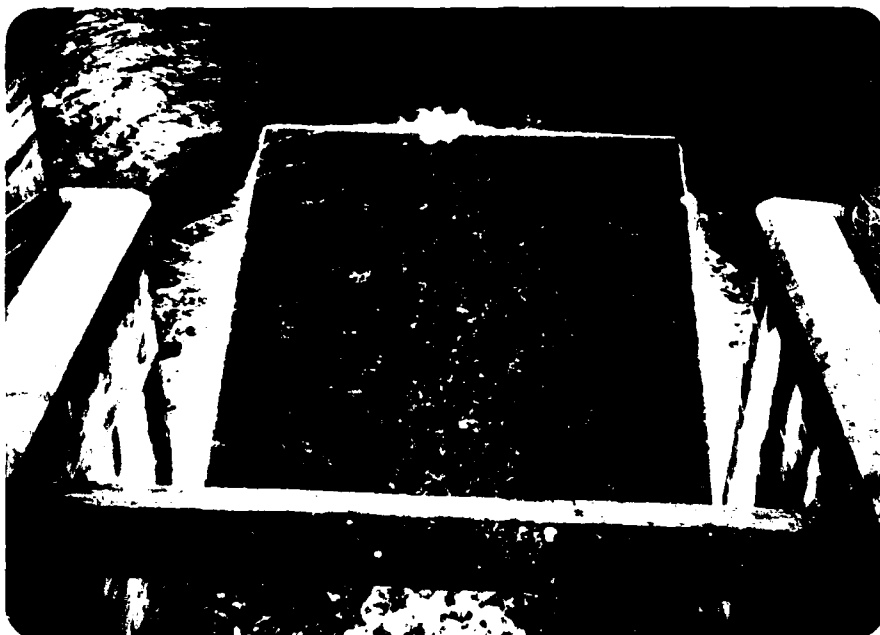
7. Discharge Channel Showing Top of Sluice Conduit, Looking Downstream.

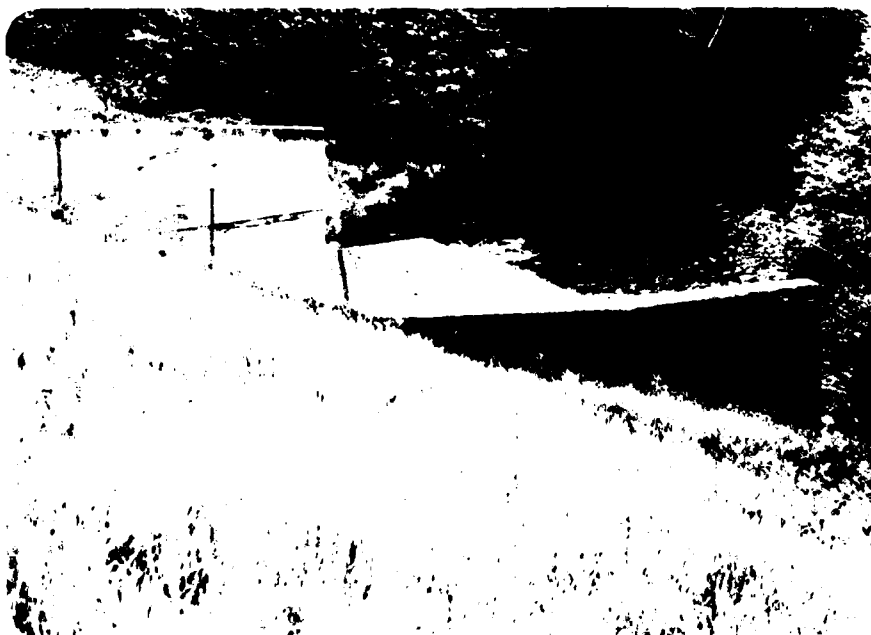
The downstream channel and side slopes are in good condition.

8. Left Abutment of Discharge Channel and Goose Pond Brook, Looking Downstream.

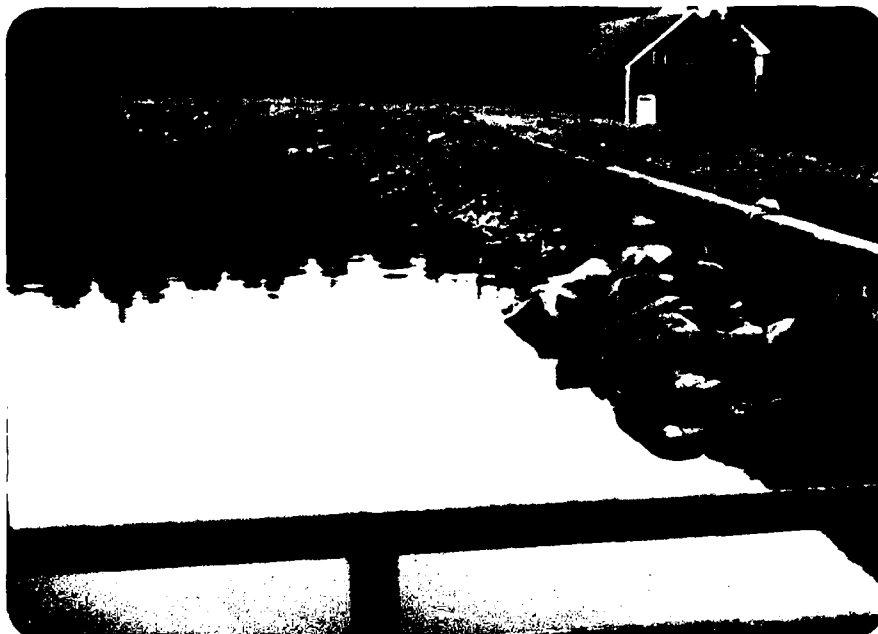
The riprap slope protection on the upstream slope is in poor to fair condition. A section of the slope protection, approximately between 66 feet and 105 feet east of the spillway, has been washed away.

11. East Dike, Showing Rip-Rap and Concrete Core Wall Near the Intake Structure.

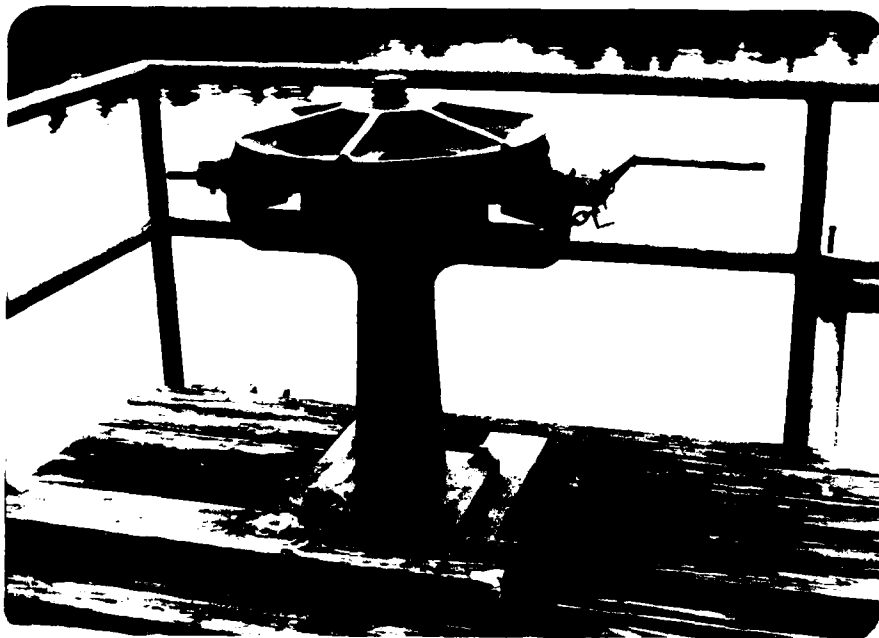
The manually operated gate shafts are supported on a platform over the spillway. The crosstred wooden planking floor of the platform and the footbridge is in very good condition. The flashboards and the manually operated gate shafts were observed to be in operable condition. The railings of the platform and the footbridge are in good condition.

14. Gate Point at the Northeast Corner of Intake Structure, with the Crank Locked.
